Weston Solutions, Inc.  
6779 Engle Road, Suites I & J  
Middleburg Heights, Ohio 44130

February 25, 2008

**Re: Interim Removal Report for the Trinity Site Removal Action  
Cleveland, Cuyahoga County, Ohio  
Technical Direction Document: S05-0711-014  
Document Control Number: 337-2A-ABOD  
Work Order No: 20405.012.003.0337.00**

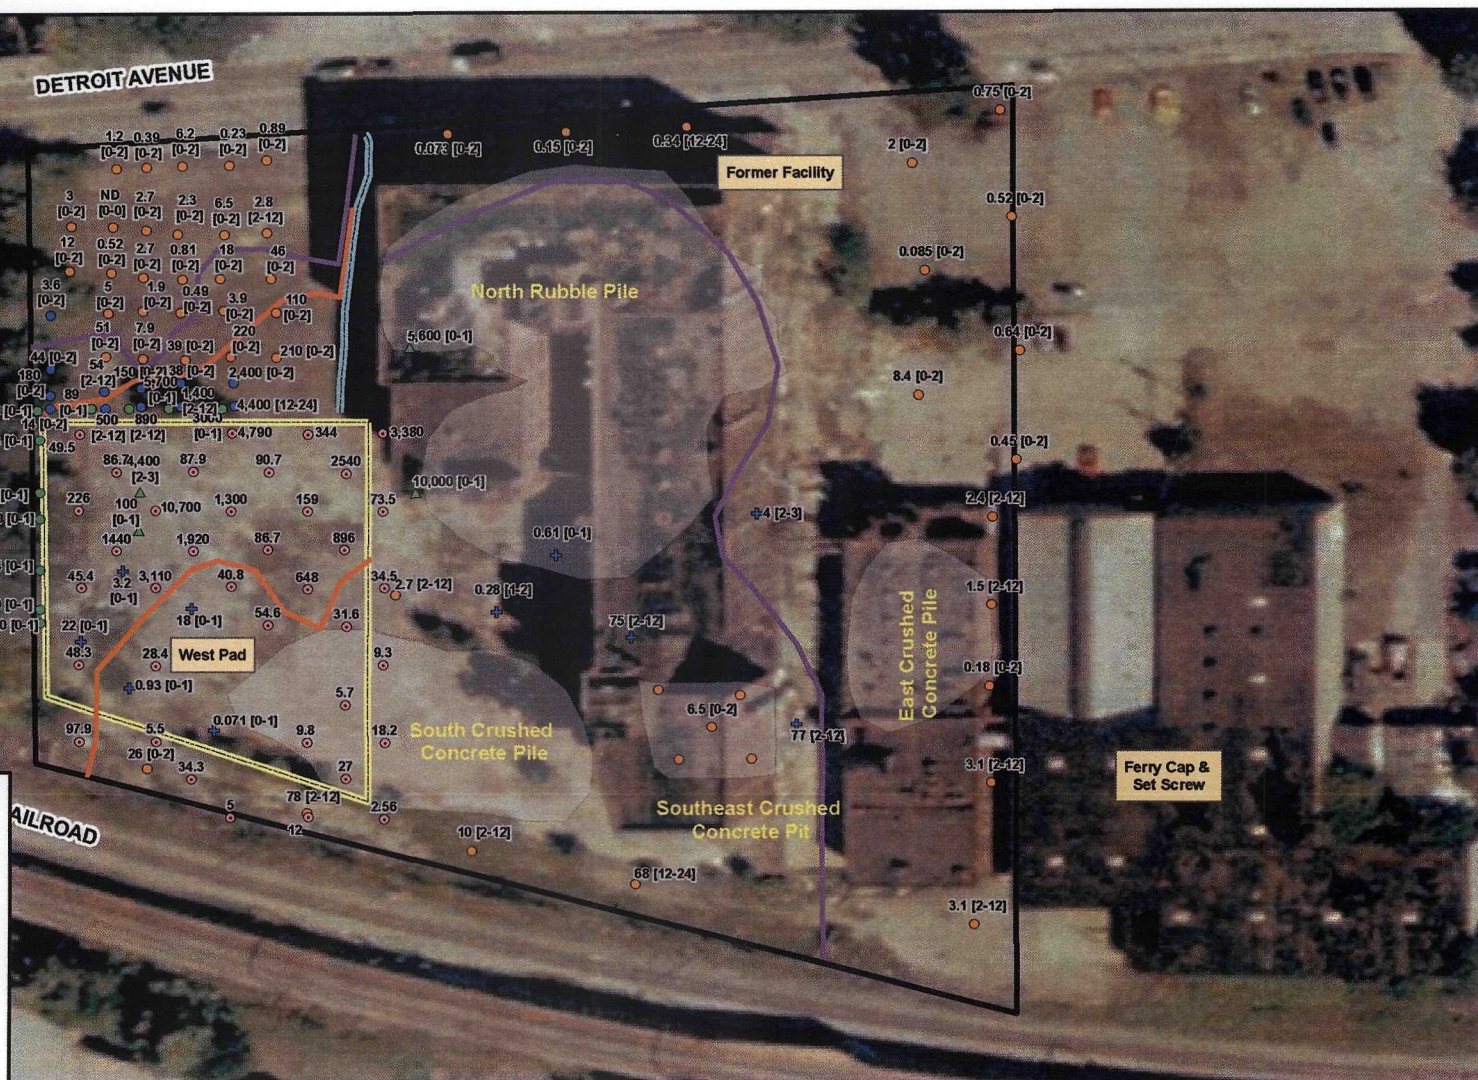
**Figure A-1**  
Soil and Concrete Aroclor 1248 Sampling Results  
and Maximum Concentration Contour Removal Map  
Trinity Interim Removal Report  
9203 Detroit Road, Cleveland, Ohio

U.S. EPA Emergency and Rapid Response Services (ERRS) contractor Inland Waters of Ohio and WESTON START were mobilized to the Site on December 3, 2007, to begin soil and concrete removal. Analytical results provided to U.S. EPA in the WESTON START site assessment report were used to delineate two on-site areas for excavation of soil and concrete that contained PCB concentrations greater than 16 mg/kg, the Ohio EPA Voluntary Action Program (VAP) Generic Direct-Contact Soil Standard for commercial and industrial property. The PCB Aroclor 1248 contour data used by WESTON START field personnel to delineate the excavation areas is included in Figure A-1. White spray paint was used to mark the 16 mg/kg contour line onto the ground surface north of the West Pad, to guide the excavator operator.

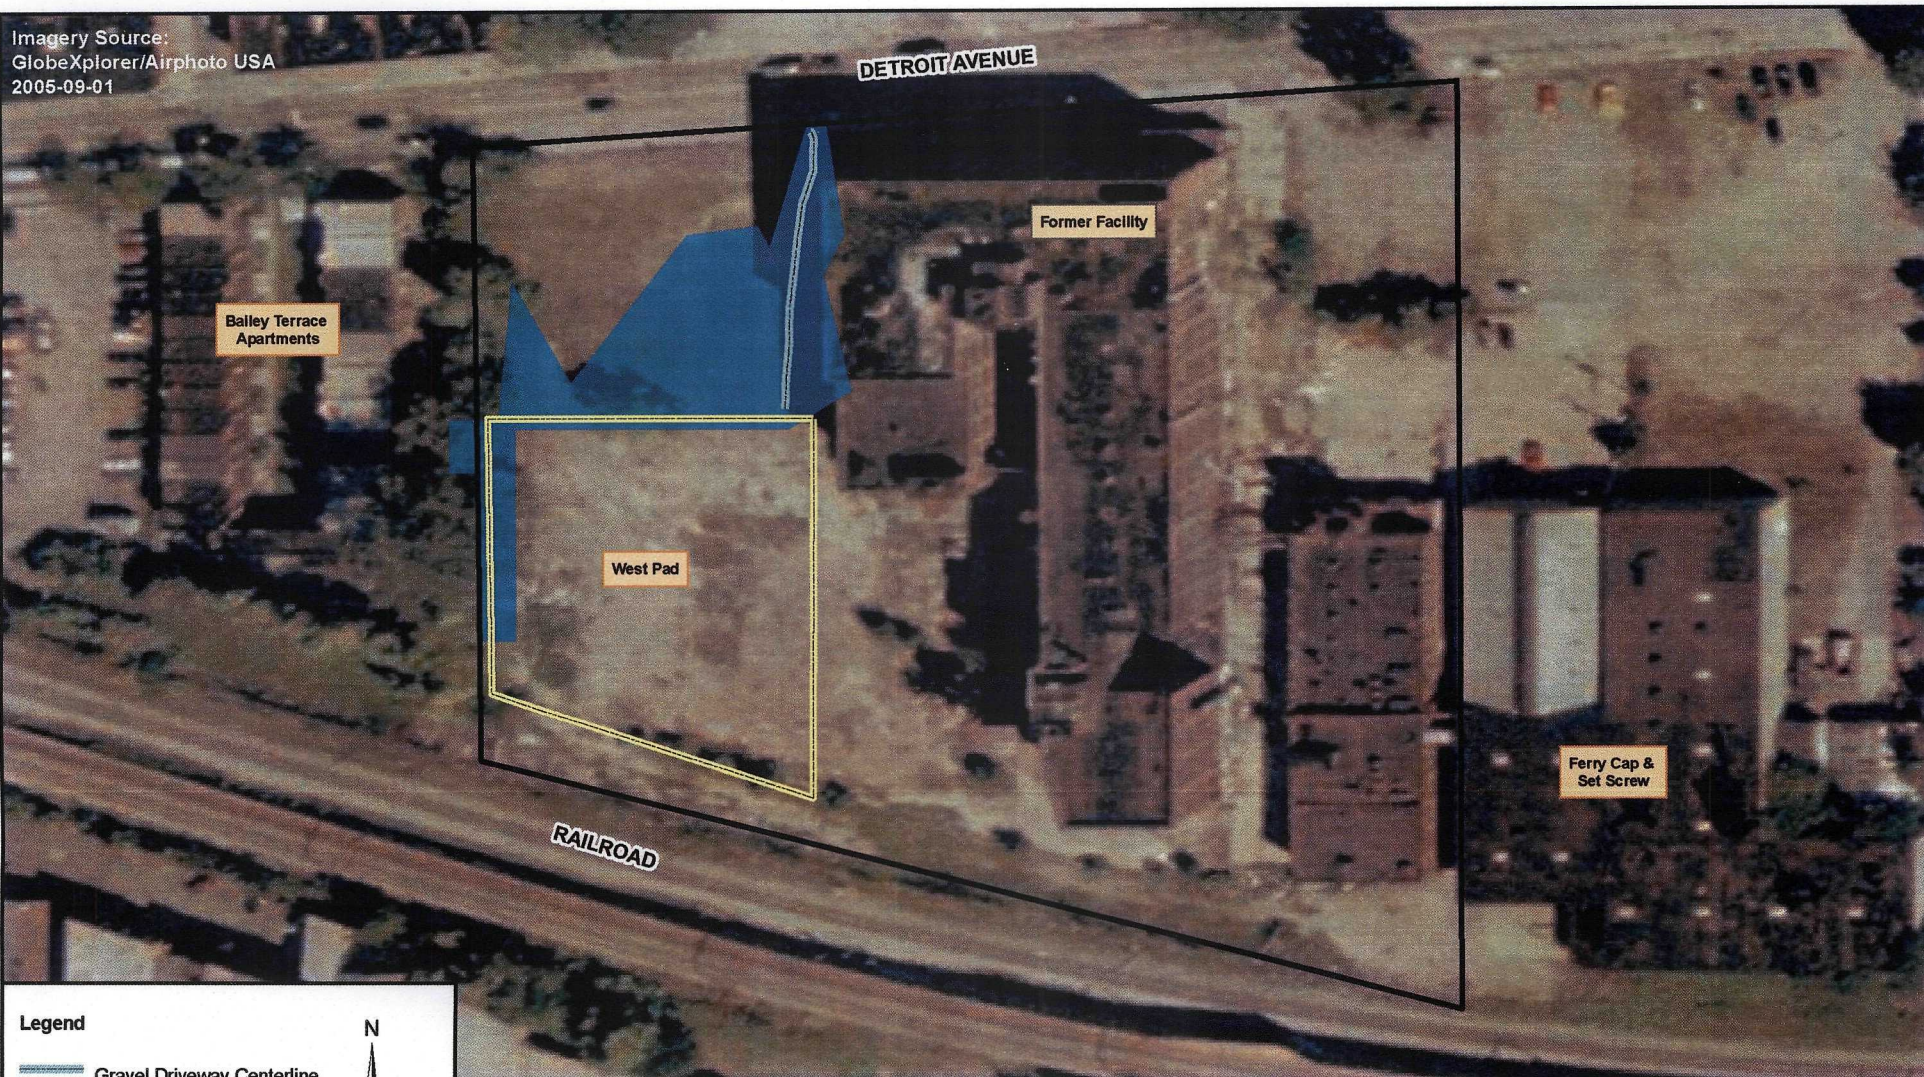
**Figure A-2**  
Areas Excavated Between December 3  
and December 11, 2007  
Trinity Interim Removal  
9203 Detroit Avenue  
Cleveland, Cuyahoga County, Ohio

In order to remove PCB-contaminated concrete and soil situated adjacent to the Bailey Terrace Apartments property, an area 10 feet wide (east-west) and 175 feet long (north-south) along the western boundary of the West Pad was marked for excavation. An area 20 feet wide (east-west) and 50 feet long (north-south) of the northwest gravel driveway was also marked for removal. The northwest gravel driveway was composed of a mixture of PCB-contaminated crushed concrete debris and soil from the demolition of the former facility, posing a risk of off-site cross-contamination. Photos 3, 4, and 5 of the photo log in Attachment B show the excavation areas prior to removal. WESTON START collected coordinates of the removal areas with a Trimble global positioning system (GPS) unit. The excavation areas are depicted in Figure A-2 of Attachment A.

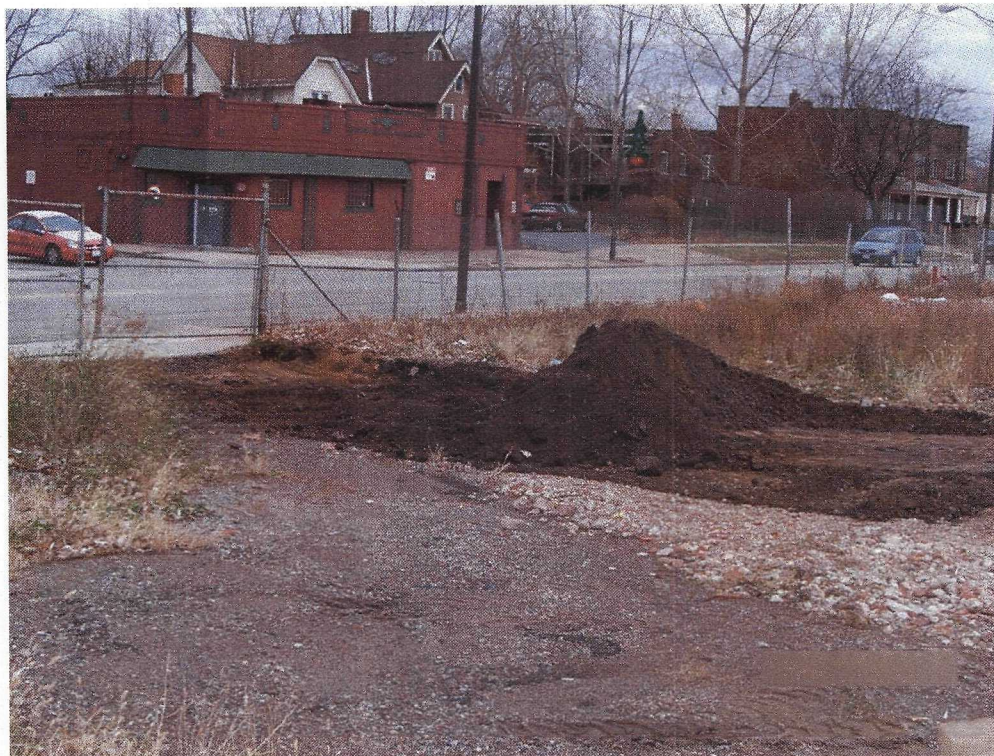
**Photo Number:** 1

**Subject:** The northwest gravel driveway, removal of the surface six to eight inches of crushed concrete in progress

ERRS mobilized one combination front-end loader and excavator to the Site on December 3, 2007. ERRS utilized the northeast entrance to the Site during the removal operations, avoiding the PCB-contaminated northwest entrance. ERRS began removing PCB-contaminated crushed concrete from the northwest gravel driveway by scraping six-to-eight inches of surface material southward (into the Site), using the front-end loader bucket (Photo 1, Attachment B). Crushed concrete removed from the driveway was temporarily staged at the northern edge of the West Pad, where PCB concentrations exceeded 50 mg/kg. On December 4, 2007, fresh crushed limestone was delivered to the Site, backfilled on the northwest gravel driveway, and compacted (Photo 2, Attachment B).

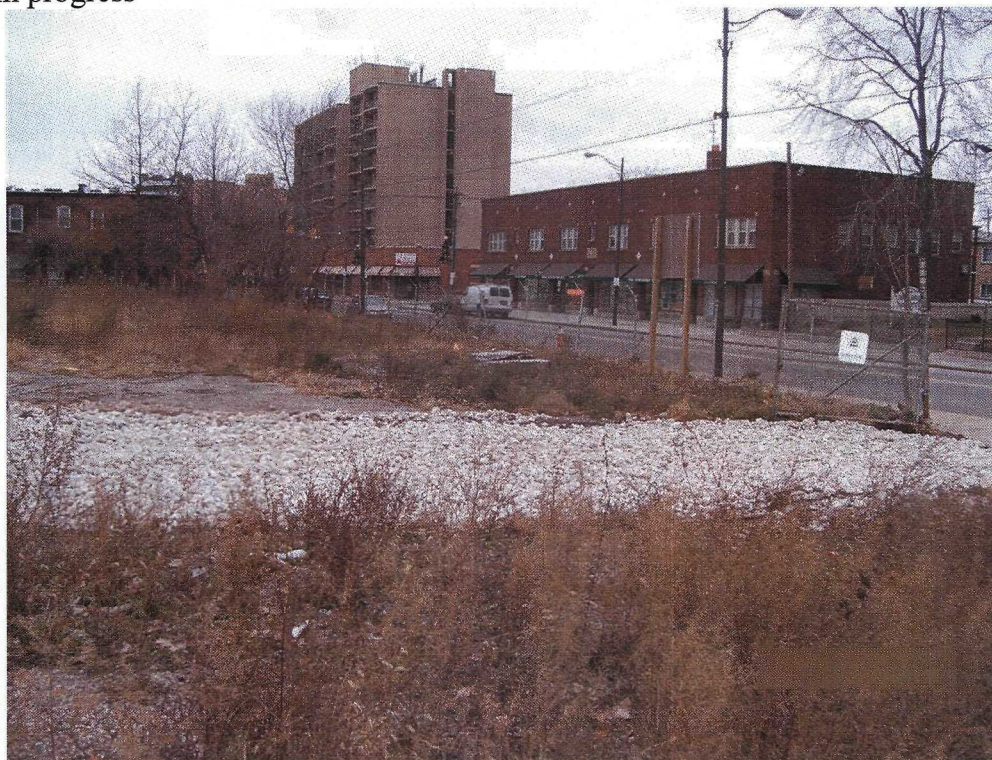
**Photo Number:** 2

**Subject:** The northwest gravel driveway, replacement crushed gravel backfill in place

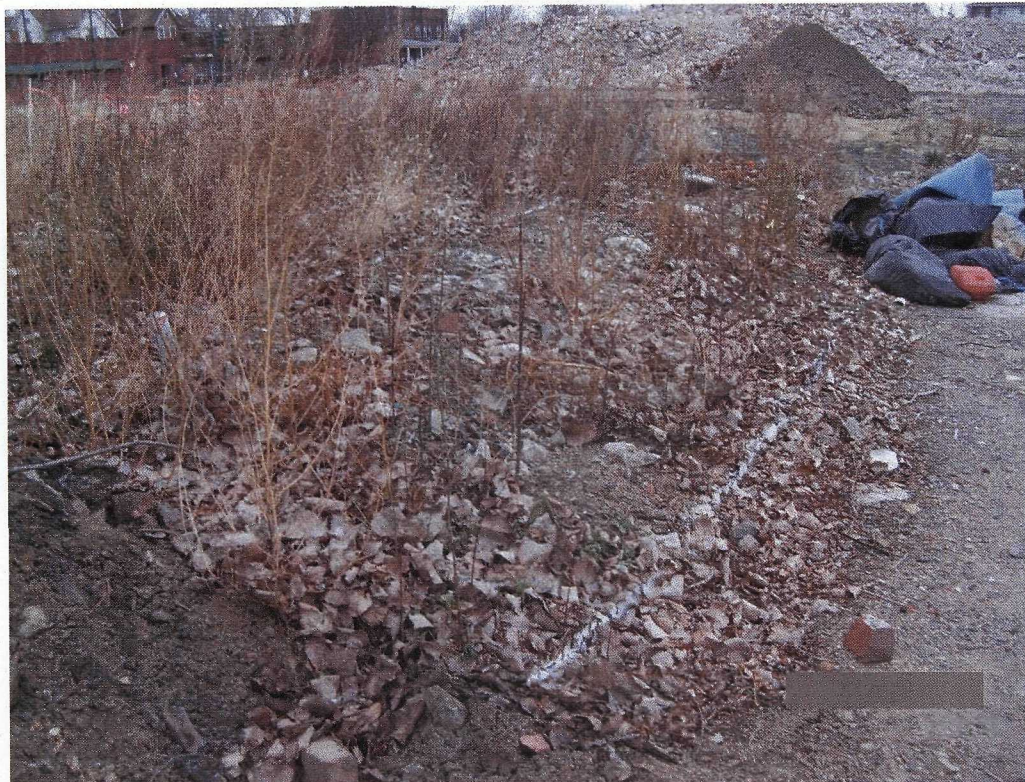
**Photo Number:** 3

**Subject:** Area north of the West Pad prior to the removal of surface soil

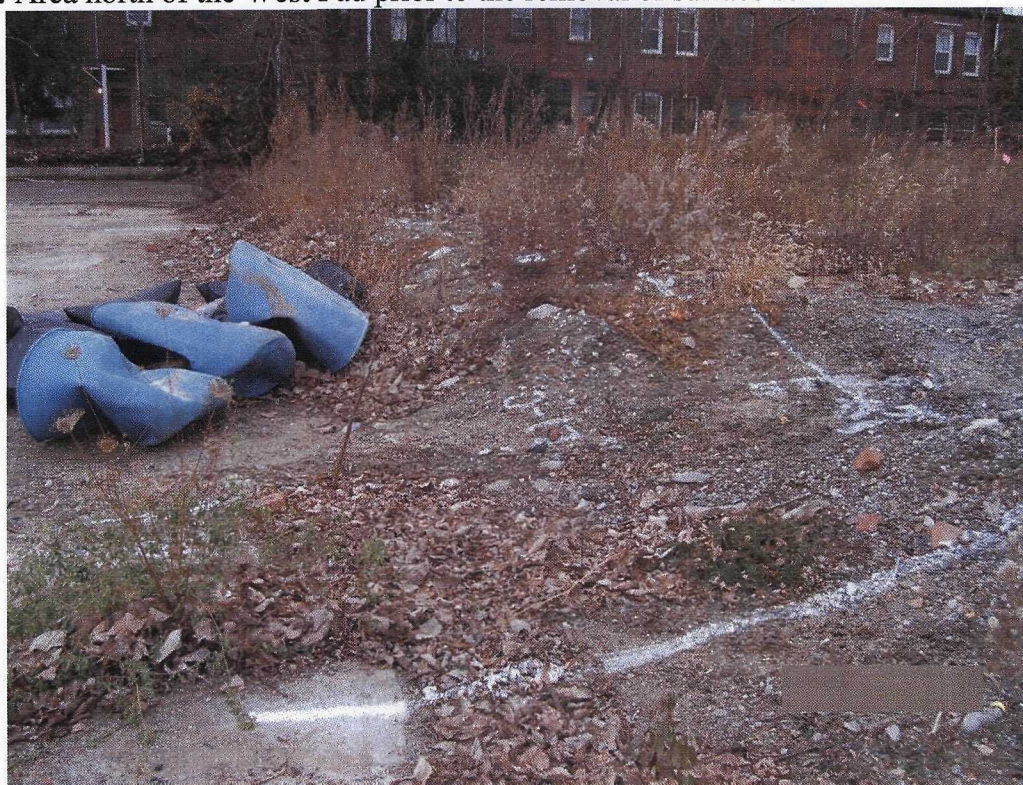
**Photo Number:** 4

**Subject:** White spray paint delineating the excavation area north of West Pad

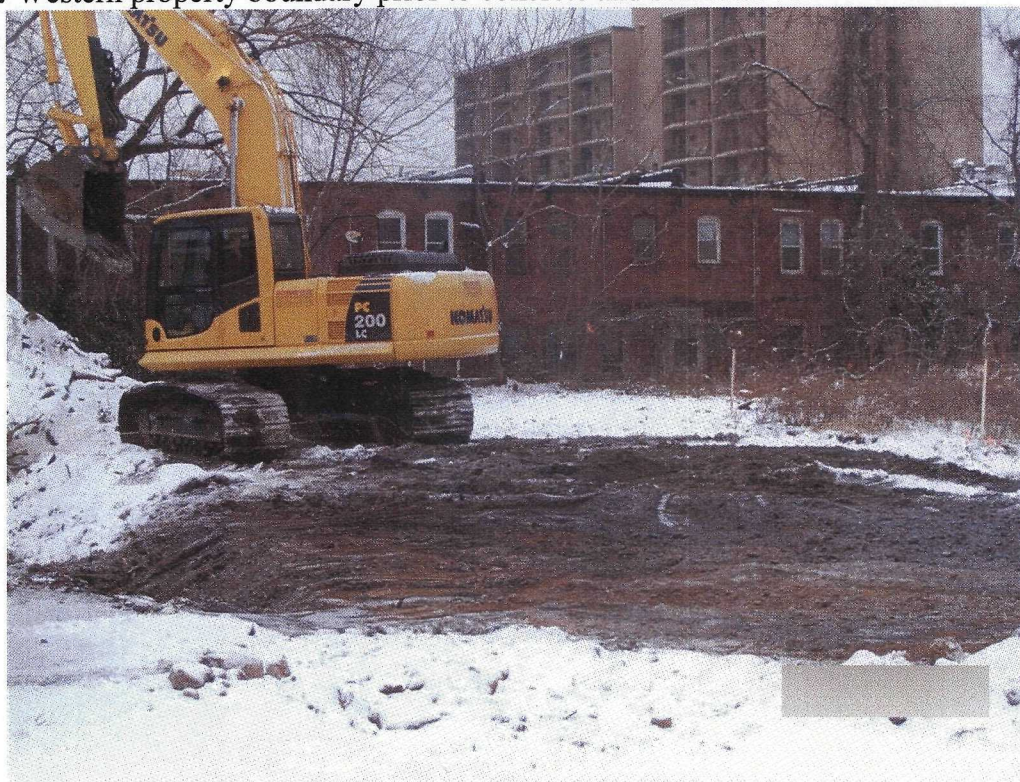
**Photo Number:** 6

**Subject:** Area north of the West Pad, removal of surface soil in progress

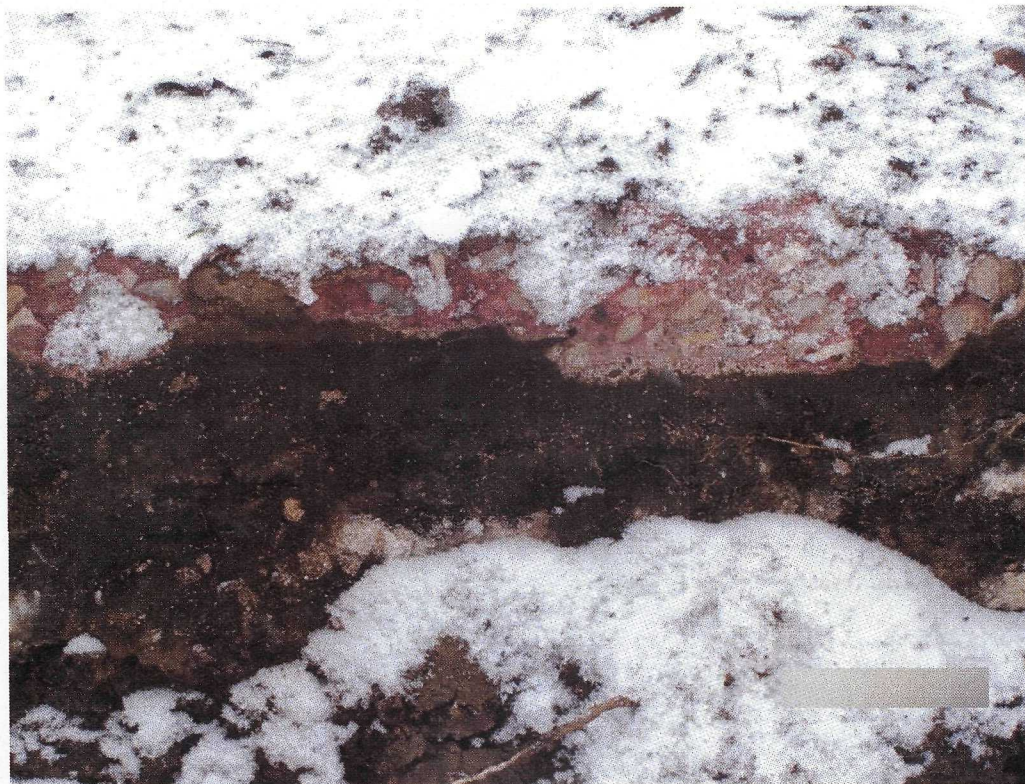
**Photo Number:** 7

**Subject:** Cross-section of the West Pad concrete slab with pink-violet staining

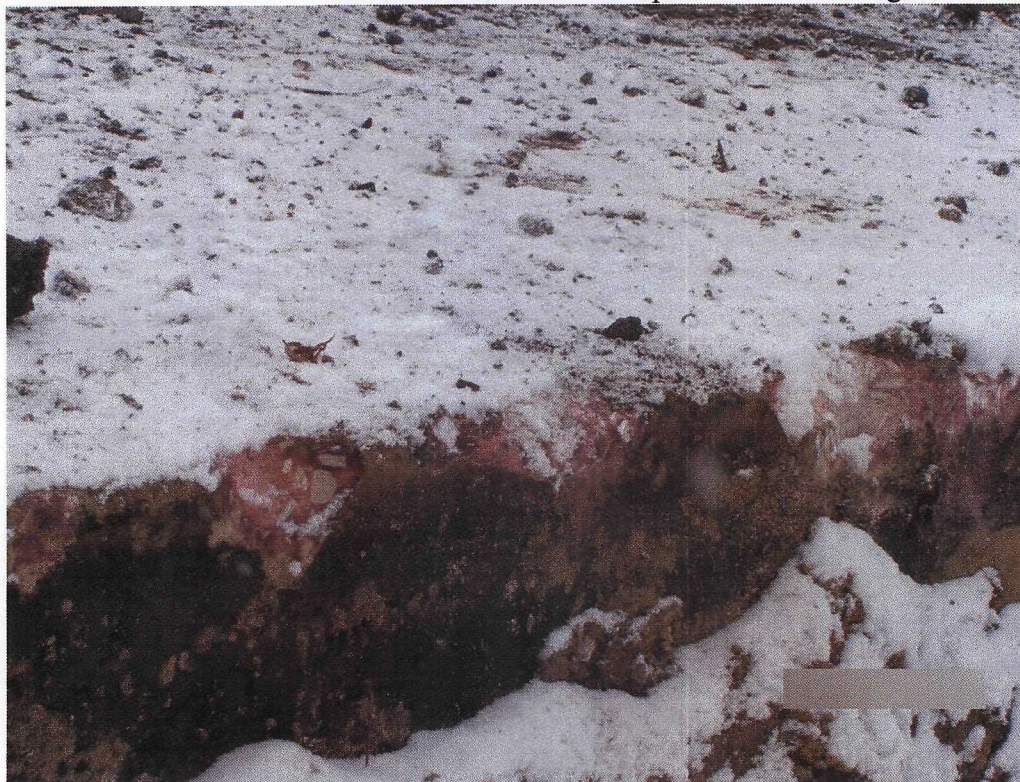
**Photo Number:** 8

**Subject:** Cross-section of the West Pad concrete slab with pink-violet staining

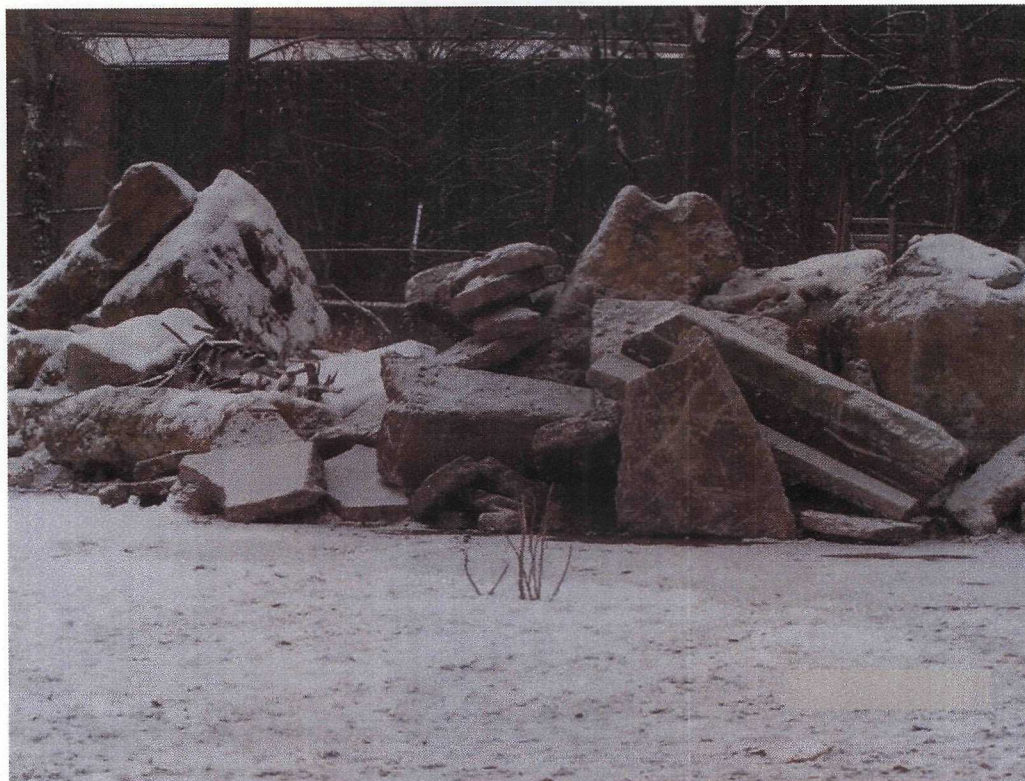
**Photo Number:** 9

**Subject:** Concrete temporarily staged on the West Pad and later removed from the Site

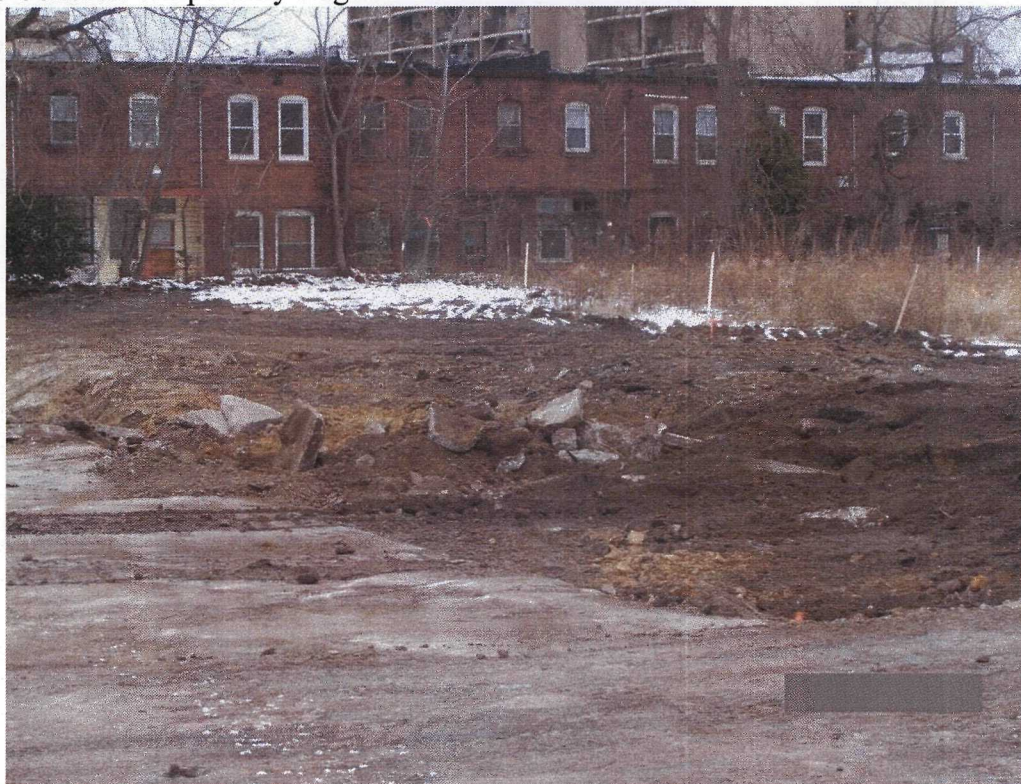
**Photo Number:** 10

**Subject:** Area north of the West Pad after removal

On December 4, 2007, ERRS mobilized an excavator to the Site for the removal of larger concrete debris and excavation work. Removal operations north of the West Pad began with excavation of a trench along the northern boundary of the West Pad, 5 feet wide (north-south), 150 feet long (east-west), and 2.5 to 3.5 feet deep (Photo 6, Attachment B). This portion was excavated to 3.5 feet below ground surface (bgs) due to the known high concentrations of Aroclor 1248 in the concrete of the West Pad and adjacent soil. The excavation work along the northern edge of the West Pad exposed a cross-sectional view of the pink-stained concrete slab (Photos 7 and 8, Attachment B) discussed in the WESTON START site assessment report dated January 29, 2008 (DCN 199-2A-ABHM), and the PCB Source Investigation letter report dated January 25, 2008 (DCN 337-2A-ABMY). Soil removed from this excavation was placed directly into dump trailers with plastic liners, while concrete waste was temporarily staged at the south end of the excavation (Photo 9, Attachment B). Excavation work north of the West Pad continued on December 5, 2007, by utilizing the front-end loader to scrape six-to-eight inches of surface soil where PCB concentrations exceeded 16 mg/kg. ERRS completed soil removal within the delineated area north of the West Pad on December 7, 2007 (Photo 10, Attachment B).

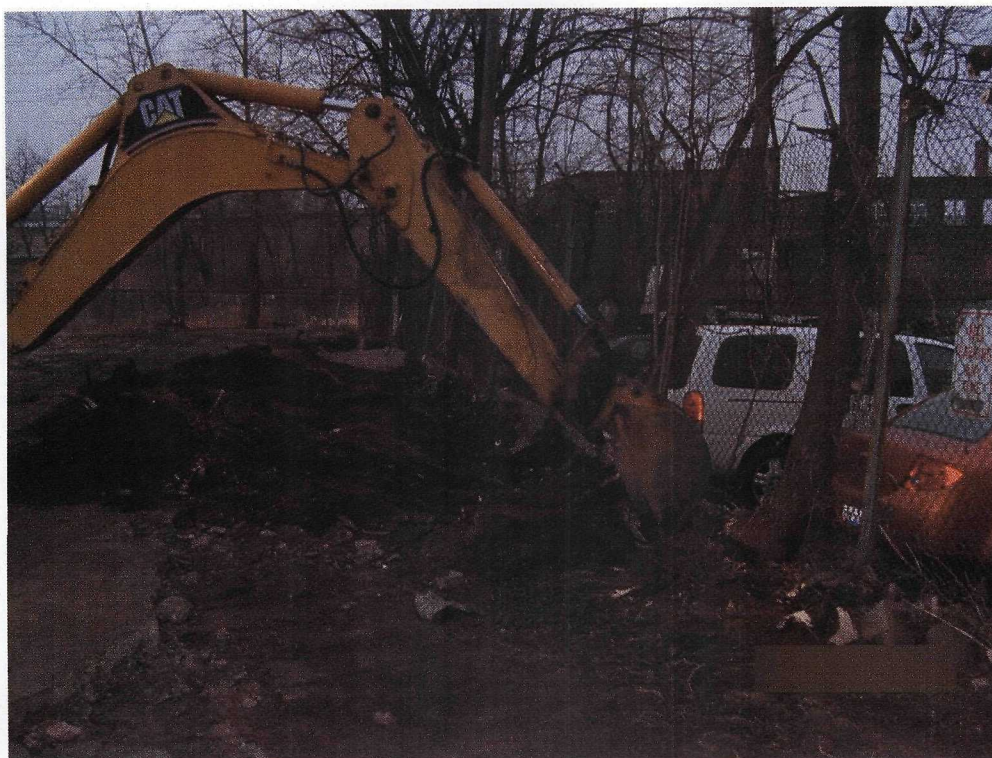
**Photo Number:** 11

**Subject:** Western property boundary, removal of concrete and soil in progress

On December 10, 2007, ERRS began excavation and removal of soil and buried concrete debris along the western property boundary. ERRS used chainsaws to remove several small trees and lower branches from larger trees to allow the excavator bucket to reach the fence line without obstructions (Photo 11, Attachment B). ERRS excavated an area 10 feet wide (east-west), 175 feet long (north-south) and 6 to 8 inches in depth along the western boundary of the West Pad. Additionally, the chain-link fence along the property boundary was temporarily disassembled at the base and pushed aside, allowing the excavator to reach one-to-two feet onto Bailey Terrace Apartments property. Soil and concrete removed from the excavation were placed directly into dump trailers for transport to the disposal facilities. ERRS completed removal operations along the western property boundary on December 11, 2007. A fresh gravel berm was placed along the fence line. Clean soil was backfilled into the remainder of the excavation (Photos 12 and 13, Attachment B).

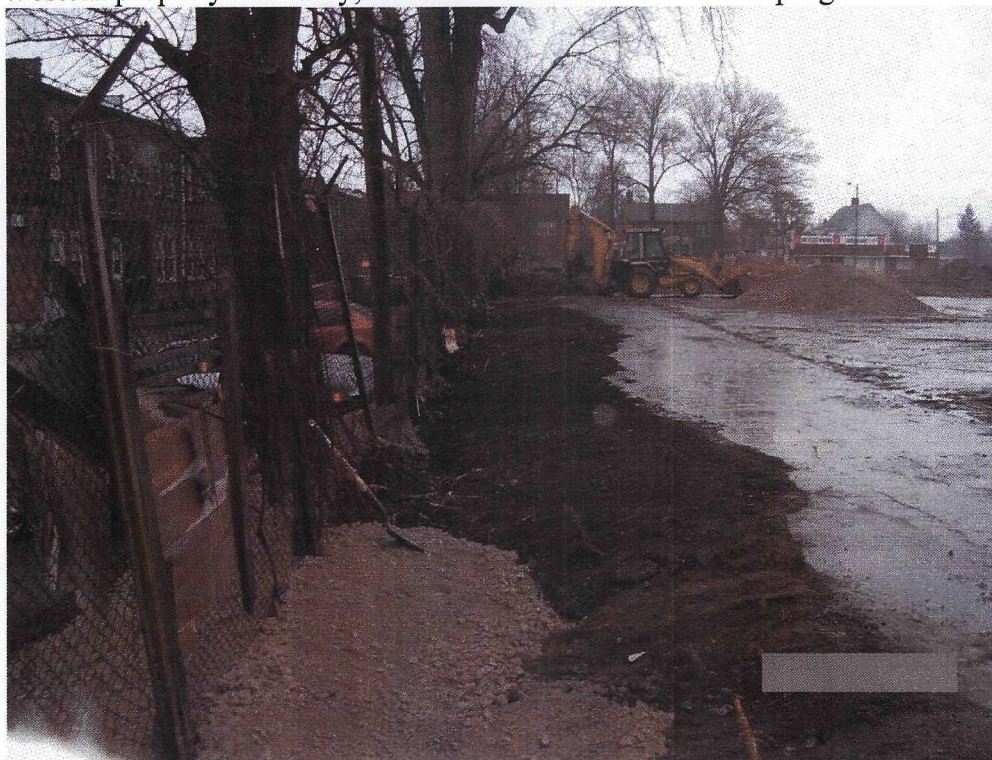
**Photo Number:** 12

**Subject:** Contractors backfilling the excavation along the western property line with fresh soil and gravel

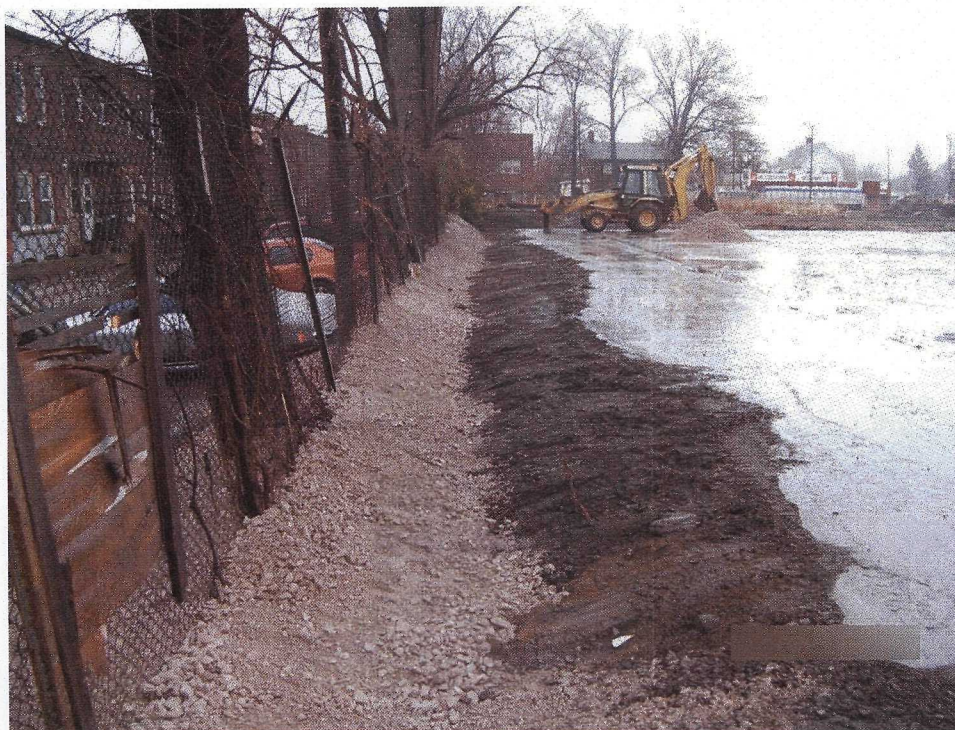
**Photo Number:** 13

**Subject:** Contractors backfilling the excavation along the western property line with fresh soil and gravel

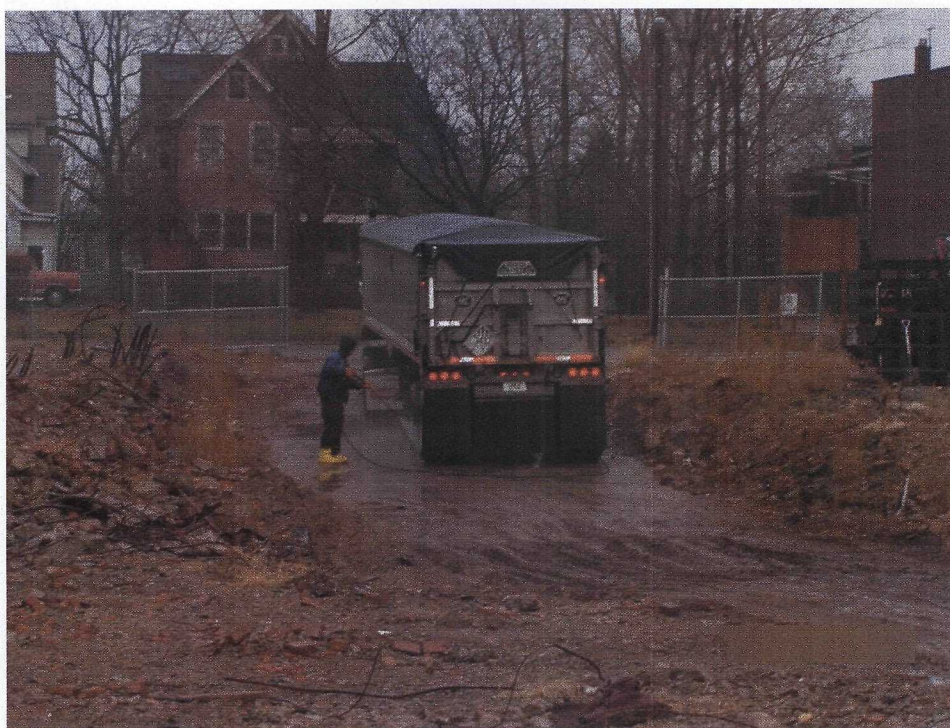
**Photo Number:** 14

**Subject:** Contractors decontamination a truck prior to departure from the Site using steam cleaning equipment

Thirty-eight trailer loads of PCB-contaminated concrete and soil were transported from the Site to two disposal facilities during the removal operations between December 3 and December 11, 2007. Prior to departing the Site, tractor trailer tires were rinsed with a steam pressure washer mobilized by ERRS (Photo 14, Attachment B). The dump trailer loads were covered with a plastic liner while in transit to the disposal facility. Manifest copies for the transportation of the waste soil were signed and retained by the U.S. EPA On-Scene Coordinator. A summary of the waste streams generated during this portion of site work is listed in Table C-1 of Attachment C.
